## ST MARY'S CHURCH – FLINT WALL

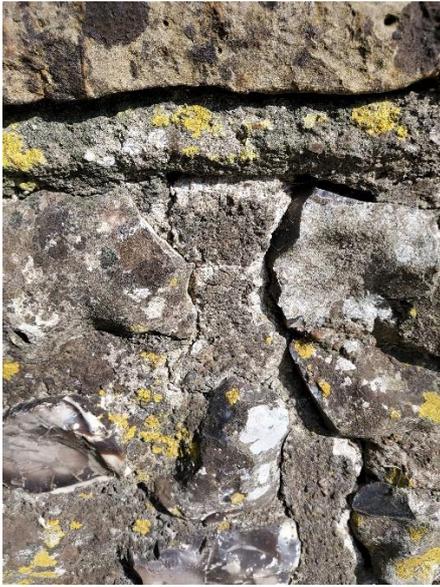
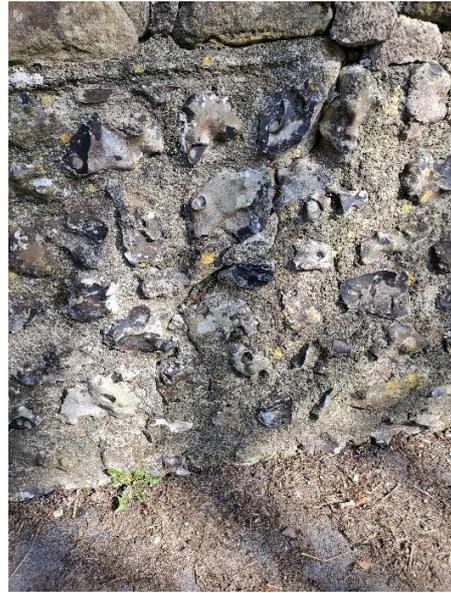
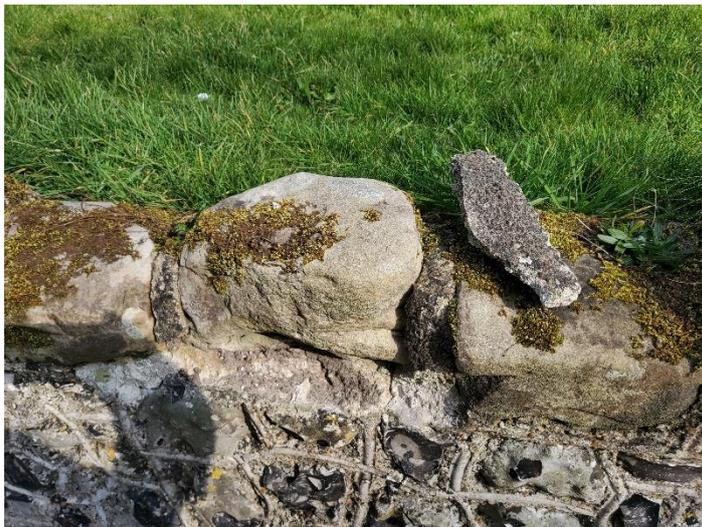
5. The section of wall on Church Hill from the small gate heading down towards Ham Lane has a number of cracks in it. There are signs of fairly modern pointing having fallen out in recent months. Some recent photographs of cracks in the wall are attached.

**PHOTOGRAPHS OF SOME OF THE CRACKS IN THE CHURCH WALL**

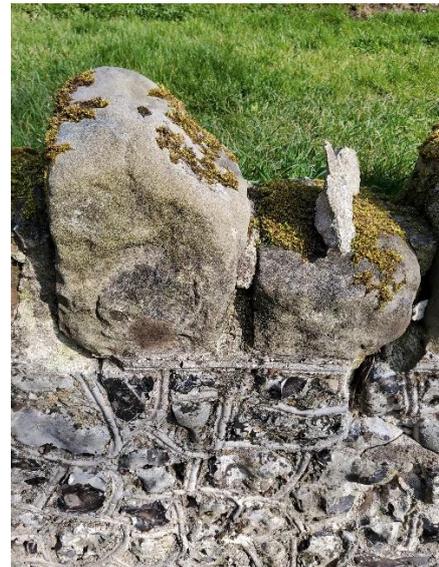
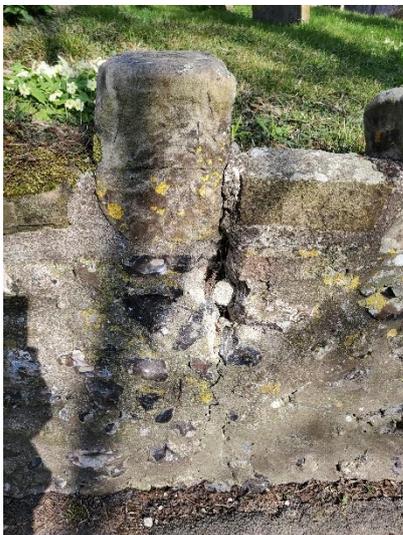
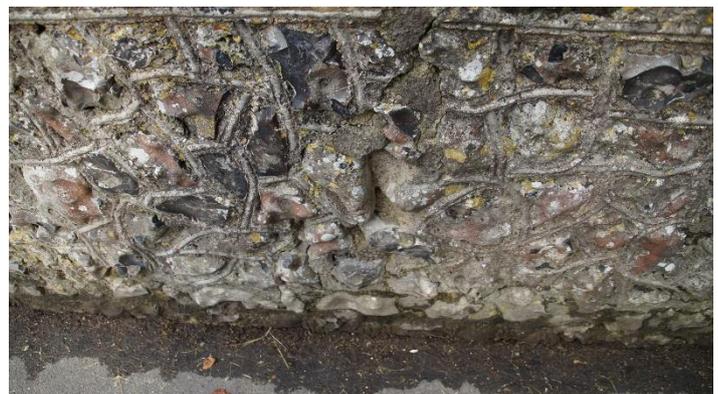
Pointing which had fallen out of the wall.
